**Rustenburg Platinum Mines Limited: Mogalakwena Mine**  
**Environmental Audit Report, 2025: Environmental Management**  
**Programme and Environmental Authorisation**

DMPR ref: LP 30/5/1/2/2/1 (50) MR

October 2025

| <b>Report title</b> | Environmental Audit Report on the Environmental Authorisation for 2025 (LP 50 MR) |

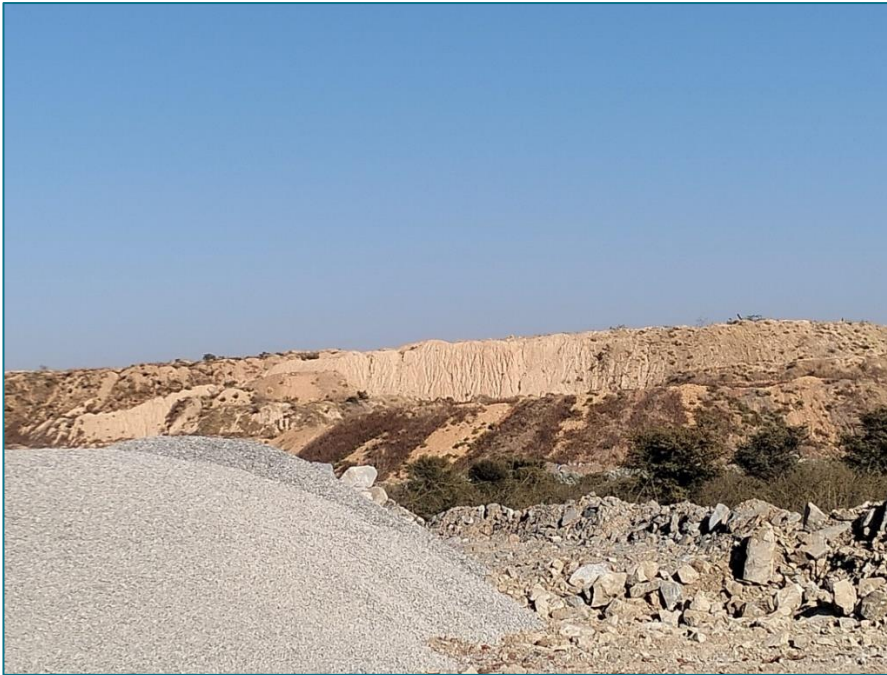
Figure 3.2-1: Topsoil stockpiles

| Description of impact and management | Findings/observations | Action plan |
|---|---|---|
| Strip soils with vegetative cover intact (inclusive of seed pool and organic matter), stockpile utilisable soils separately from soft overburden, restrict stockpiles and berms to less than 1.5 m high where possible, or to 15 m high where soils are to be stored for extended periods of time (>3 years) | <b>Full compliance:</b><br>The storage of soils on-site adheres to this condition.<br><br><b><u>Audit trail/supporting documentation:</u></b><br>Observations on-site.<br>Figure 3.2-1: Topsoil stockpiles | |

| Description of impact and management | Findings/observations | Action plan |
|---|---|---|
| Soil stockpiles will be treated with temporary soil stabilization and erosion control measures. Stockpiles must be revegetated to establish a vegetation cover as an erosion control measure | <p><b>Non-compliance:</b></p> <p>Erosion was observed on topsoil stockpiles, and the stockpiles were sparsely vegetated if at all.</p> <p><b><u>Audit trail/supporting documentation:</u></b></p> <p>Figure 3.2-1: Topsoil stockpiles</p> | <p>Ensure that all erosion measures are implemented on topsoil stockpiles.</p> <p>Ensure that erosion is monitored frequently for topsoil stockpiles.</p> <p><b><u>Responsible person:</u></b></p> <p>ECO<sup>10</sup>/mine manager</p> <p><b><u>Timeframe:</u></b></p> <p>Ongoing</p> |

| Description of impact and management | Findings/observations | Action plan |
|---|---|---|
| Suitable indigenous grass should be used as an erosion prevention medium ahead of clearing where erosion is a considered risk. | <p><b>Non-compliance:</b></p> <p>Erosion was observed on topsoil stockpiles which are not vegetated or protected from erosion.</p> <p><b>Audit trail/supporting documentation:</b></p> <p>Observations on-site.</p> | <p><b>Timeframe:</b></p> <p>Ongoing</p> |

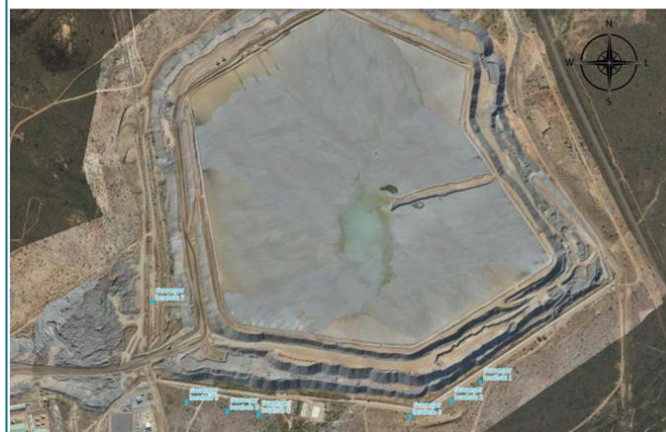
**Mogalakwena Blinkwater TSF Scavenger Boreholes**

- Boreholes are drilled, equipped and operational
- Abstraction from boreholes is measured and accounted via magnetic flowmeters

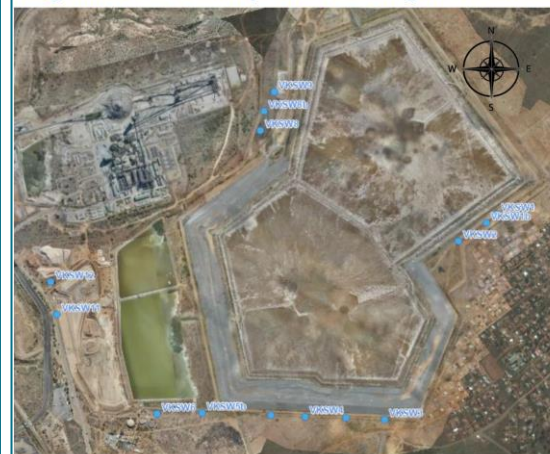
**Mogalakwena Vaalkop TSF Scavenger Boreholes**

- Boreholes testing & analysis complete
- Boreholes drilled
- Procurement of pumps & housing structures underway

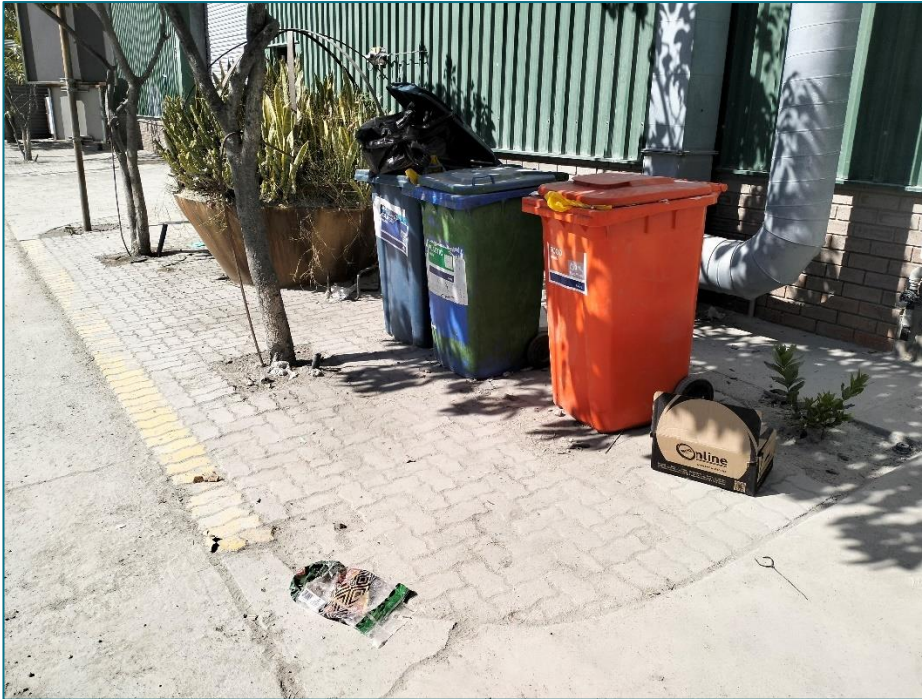
Figure 4.6-3: Overfilled waste bins

| EA ref | Condition description | Findings/observations | Action plans |
|---|---|---|---|
| 4.18<br>Page 28<br>of 31 | In order to prevent nuisance conditions, the holder of the EA must ensure that all storage skips and bins are not overfilled. | <p><b>Non-compliance:</b></p> <p>There were bins on-site that were overflowing with waste. Waste was also not separated correctly into the different waste bins</p> <p><b><u>Audit trail/supporting documentation:</u></b></p> <p>Figure 4.6-3: Overfilled waste bins</p> | <p>Ensure waste bins are not overfilled, and waste is stored in the correct receptacles.</p> <p><b><u>Responsible person:</u></b></p> <p>ECO</p> <p><b><u>Timeframe:</u></b></p> <p>Ongoing</p> |
