# Valterra Platinum GISTM Disclosure Report

This Report summarises information related to the **Tailings Storage Facilities (TSFs) at the mines operated by the subsidiaries of Valterra Platinum (VP)**, including data specified by the Global Industry Standard on Tailings Management (GISTM)<sup>1</sup> Requirement 15.1 as well as a summary of current GISTM conformance levels.

## 1 – TSF Descriptions

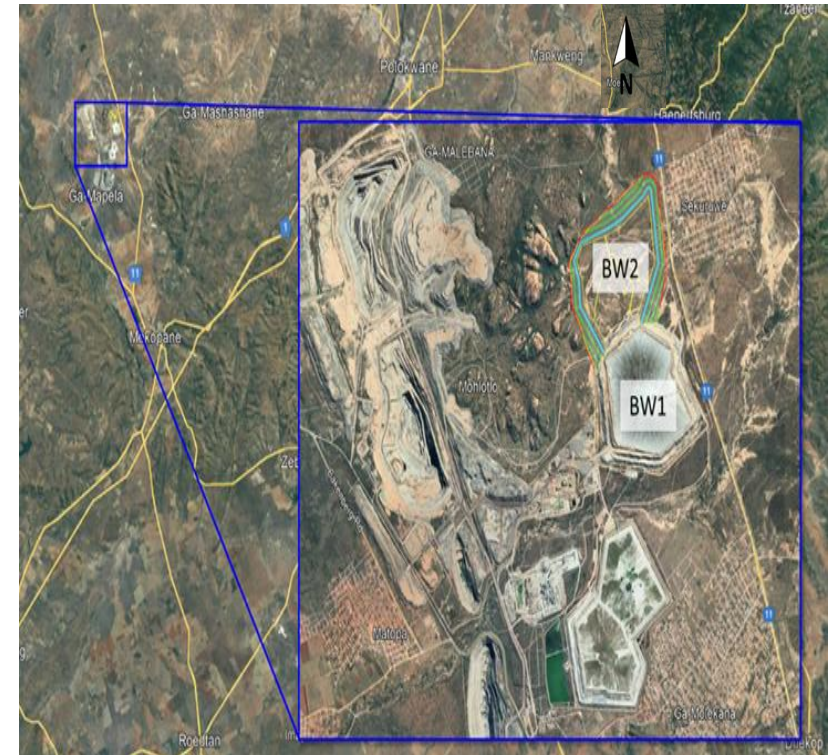
**Figure 1: Blinkwater 2 (BW2) TSF Locality**

An alternatives assessment was conducted for the facility to evaluate a range of potential development options and inform the selection of the preferred alternative. The alternatives considered various outer wall construction geometries and methodologies, as well as alternative tailings deposition methods, including paste tailings, filtered tailings, and cycloning. The options assessed included a raise of Blinkwater 1 TSF, three potential locations for Blinkwater 2 TSF, and in-pit deposition within existing open pits. For the Blinkwater 1 raise and the new Blinkwater 2 TSF location alternatives, tailings storage was based on placement behind an engineered embankment constructed using the downstream construction method. Notwithstanding this, Blinkwater 2 TSF has been designed using external loading design criteria corresponding to an Extreme Consequence Classification, in accordance with the Valterra Platinum Processed Mineral Residue Standard, which is aligned with the GISTM.

An Environmental Impact Assessment report was compiled and submitted to the relevant authorities. The specialist impact studies included in the Environmental Impact Assessment report were: air quality, socio-economic, rehabilitation and closure, biodiversity (including wetlands), hydrology, geohydrology, noise, visual, heritage and soil/land use capability. The socio-economic impact assessment was undertaken which includes impacts to neighbouring communities and locals. A public participation process was followed which allows for input from all interested and affected parties including locals. Blinkwater 2 TSF was subsequently granted a further environmental authorisation by the Department of Mineral and Petroleum on 13 August 2020. In addition, Blinkwater 2 TSF was also granted a waste management license and water use license from the Department of Water and Sanitation. The development of this new facility commenced with the execution of early works in 2025, followed by the commencement of the main construction phase in early 2026.
